StuccoSpec Moisture Testing Inspection

Property Located At:
265 Elm Street, Anywhere, USA

01/27/02

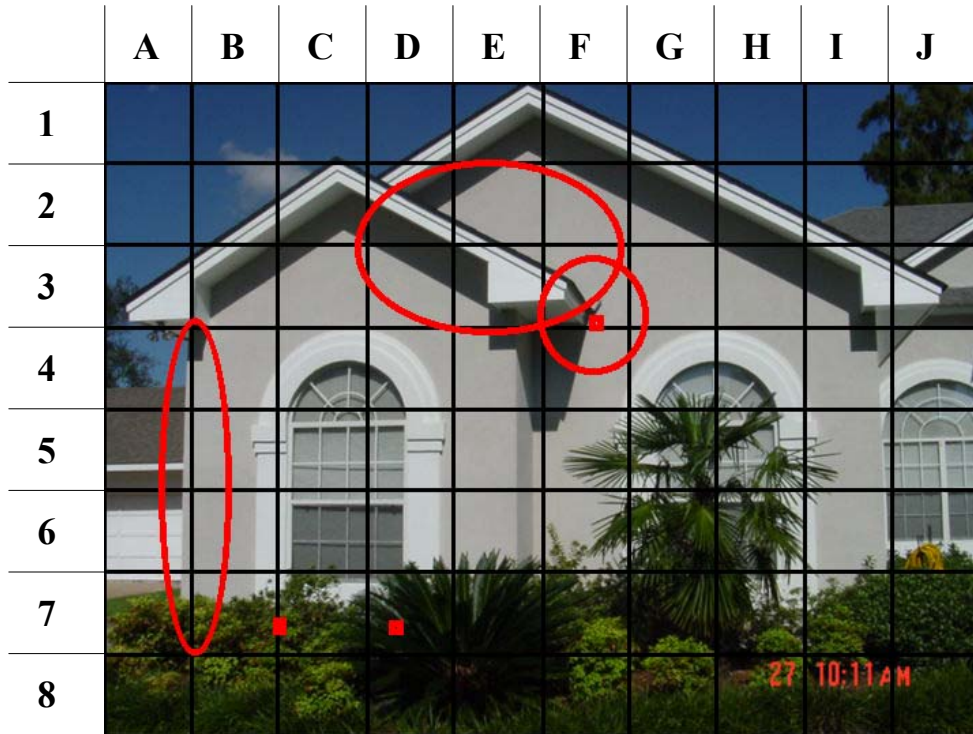
Photo #1a ---- 265 Elm Street

Grid Site	Description of Problem	Moisture Readings		Read for Add'l Info
		% Wet	Equipment	
A/B4 - A/B7	Brick Terminations. See Detail #1 Seal all brick/EIFS terminations to prevent moisture intrusion.			Ch 3.10
B/C7	High moisture reading at window lower left. No sealants present.	80%	Firm	
D7	High moisture reading at window lower right below the band 23% Firm at the band. All windows and other penetrations need perimeters sealed Seal all window construction.	40+%	Firm	Ch 3.1,3.2 Ch 3.2
F3,4	Area where moisture probe was made under kickout flashing. See Detail #2 Kickout flashing is present. Seal all kickouts.	8%	Firm	
D2-F3	EIFS is flush on roofline. See Detail #3 Consult a qualified water- proofing contractor to modify as needed to prevent moisture intrusion and corrosion of flashing. Typical.

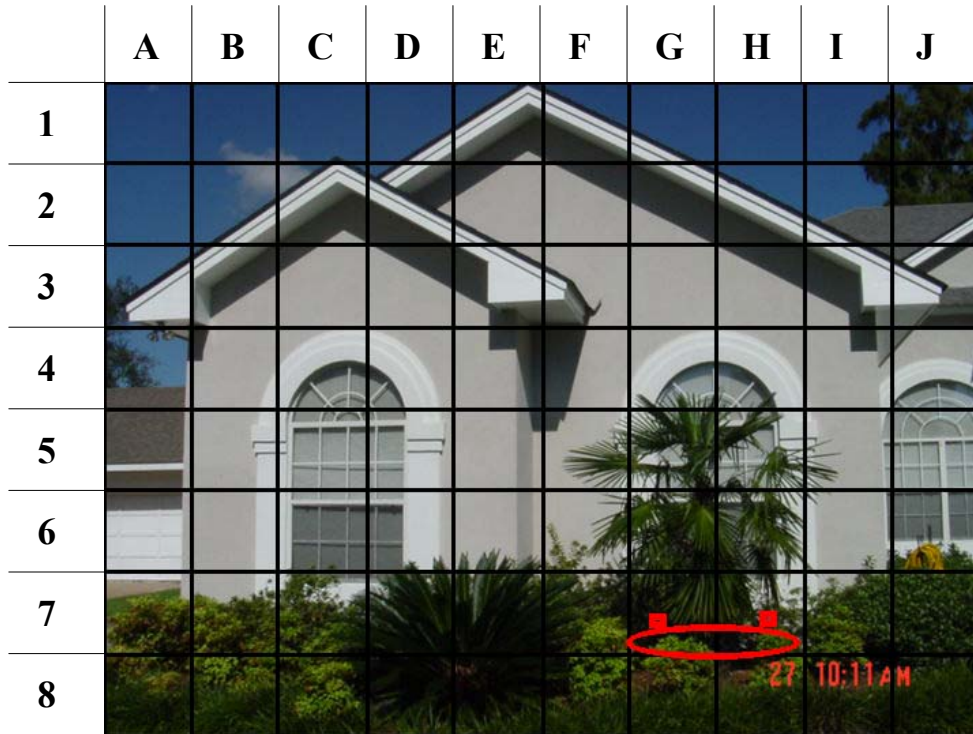
Photo #1b ---- 265 Elm Street

Grid Site	Description of Problem	Moisture Readings		Read for Add'l Info
		% Wet	Equipment	
E/F3,4	Soffit/Fascia. See Detail #4 No sealants present. Seal all soffit/fascia terminations to prevent moisture intrusion.			Ch 3.10
G7	High moisture reading at window lower left. See Detail #5 Soft substrate noted when probing this area. No sealants.	34%	Soft	
H7	High moisture reading at window lower right. No sealants. Soft substrate noted when probing this area. Inspector's Note: Repair is probably necessary beneath this window (approx. 8 Sq. Ft.) Ants emerged from the probe holes beneath this window. Consult with inspection specialist to investigate this area further.	30%	Soft	
	All windows and other penetrations need perimeters sealed			Ch 3.1,3.2
	Seal all window construction.			Ch 3.2

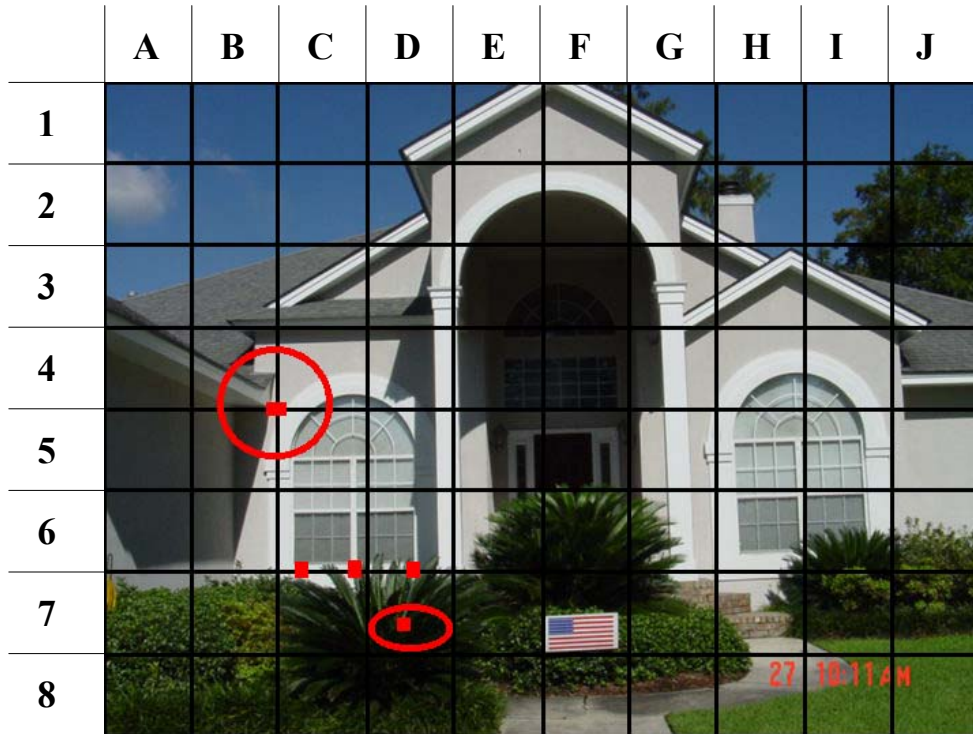
Photo #2a ---- 265 Elm Street

Grid Site	Description of Problem	Moisture Readings		Read for Add'l Info
		% Wet	Equipment	
B/C4,5	Area where moisture probe was made under kickout flashing. See Detail #6 -- EIFS is flush on roofing/flashing. Consult a qualified waterproofing contractor to modify kickout/EIFS to roof termination to prevent moisture intrusion & corrosion.	18%	Firm	
C6,7	Area where moisture probe was made at window lower left.	16%	Firm	
C6,7	High moisture reading at window lower middle.	19%	Firm	
D6,7	High moisture reading at window lower right. All windows / Doors / other penetrations need perimeters sealed Seal all window and door construction.	30%	Firm	Ch 3.1,3.2 Ch 3.2
D7	High moisture reading at lower edge. See Detail #7 Landscaping is too close to foundation grade. Raw EPS foam observed at bottom terminations. Assess and modify. Consult a qualified waterproofing contractor to assess and modify as needed to prevent moisture intrusion and insect infestation.	40%	Firm	Ch 3.3

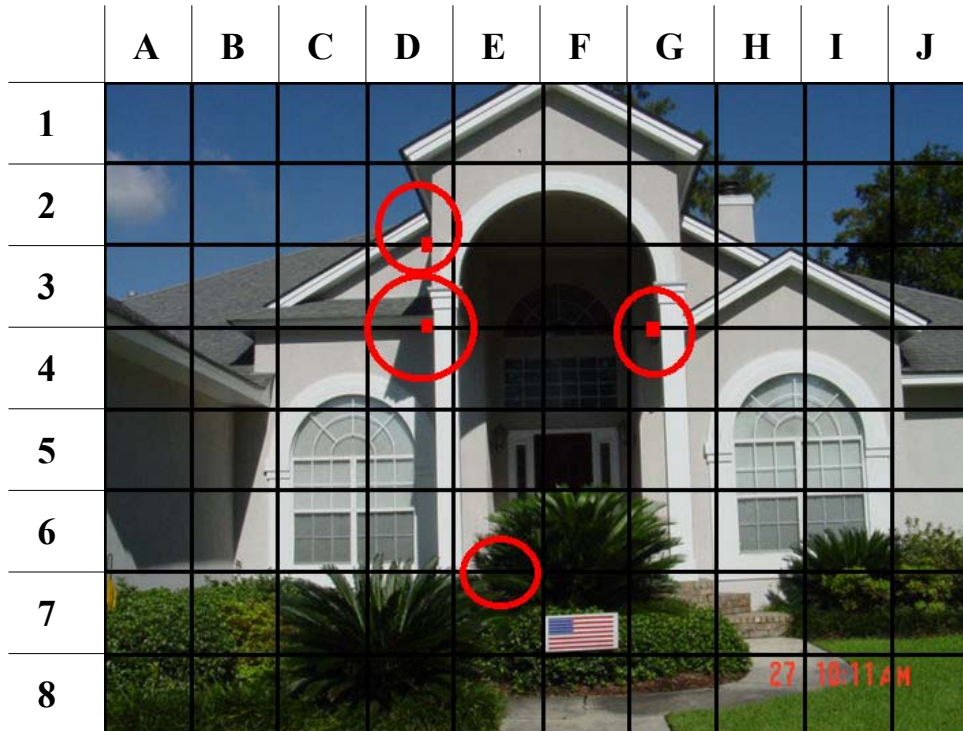
Photo #2b ---- 265 Elm Street

Grid Site	Description of Problem	Moisture Readings		Read for Add'l Info
		% Wet	Equipment	
D3,4	Area where moisture probe was made under kickout flashing. See Detail #8 Kickout flashing is present.	14%	Firm	
F/G3,4	High moisture reading under kickout flashing. See Detail #9 It appears that this kickout was installed sometime after the original EIFS installation. There is a noticeable "patch" present. Consult a qualified waterproofing contractor to seal and modify this kickout flashing to prevent moisture intrusion.	34%	Firm	
D2,3	Area where moisture probe was made under kickout flashing. See Detail #10 Kickout flashing is present.	8%	Firm	
E6,7	Porch Floor Termination. See Detail #11			
	EIFS is flush on porch floor. Consult a qualified waterproofing contractor to assess and modify as needed to prevent moisture			Ch 3.3
	intrusion and wicking. Seal all window and door construction.			Ch 3.2
	All windows / Doors / other penetrations need perimeters sealed			Ch 3.1,3.2

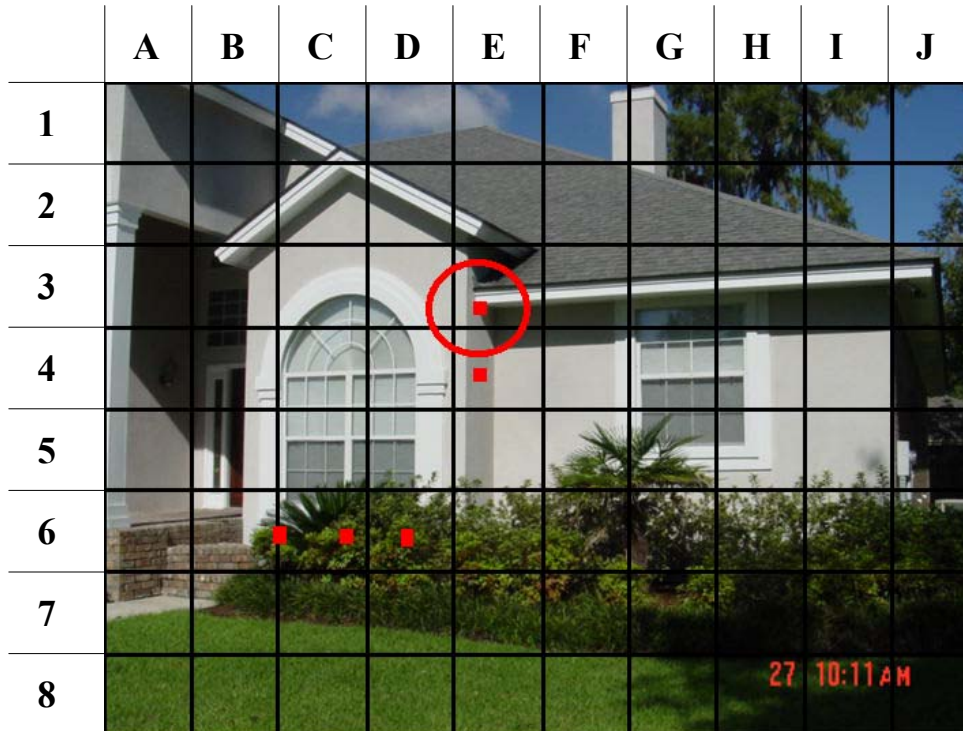
Photo #3a ---- 265 Elm Street

Grid Site	Description of Problem	Moisture Readings		Read for Add'l Info
		% Wet	Equipment	
B/C6	High moisture reading at window lower left.	22%	Firm	
C6	High moisture reading at window lower middle.	38%	Soft	
D6	High moisture reading at window lower right. See Detail #12 Soft substrate noted when probing these areas. All windows / Doors / other penetrations need perimeters sealed Seal all window and door construction.	40%	Soft	Ch 3.1,3.2 Ch 3.2
E3	High moisture reading under kickout flashing. See Detail #13	40+%	Soft	
E4	High moisture reading under kickout flashing. Kickout flashings are present at both locations. Note: Kickouts are in contact with roof shingles. Kickout is at a 90 degree angle should be a 45 degree angle. Approx. 6 square feet of rotten substrate is beneath this kickout. Repairs are necessary. Consult a qualified waterproofing contractor to modify this kickout flashing to prevent moisture intrusion.	40+%	Firm

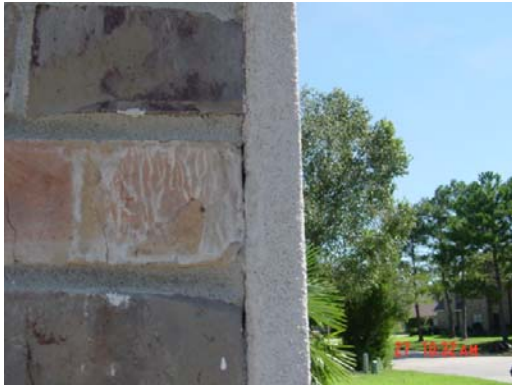
Detail Photo #1 -- Brick Terminations. No sealants present. Seal all brick/EIFS terminations to prevent moisture

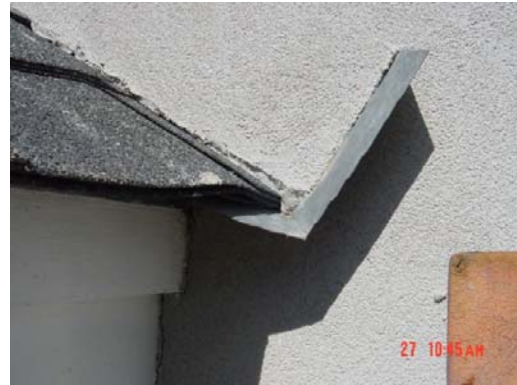
Detail Photo #2 -- Kickout flashing is present. Seal all kickouts.

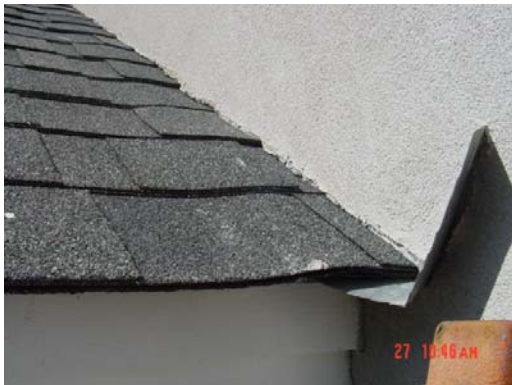
Detail Photo #3 -- EIFS is flush on roofing. Consult a qualified waterproofing contractor to modify.

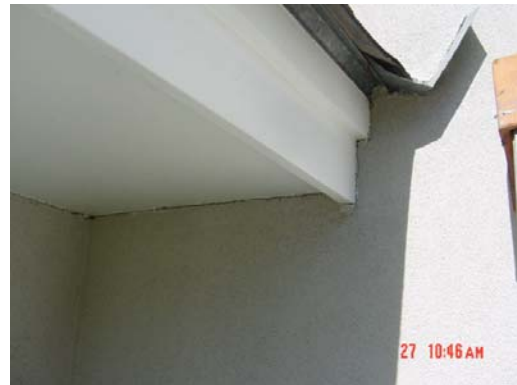
Detail Photo #4 -- No sealants at soffit/fascia. Seal all soffit/fascia areas to prevent moisture intrusion.

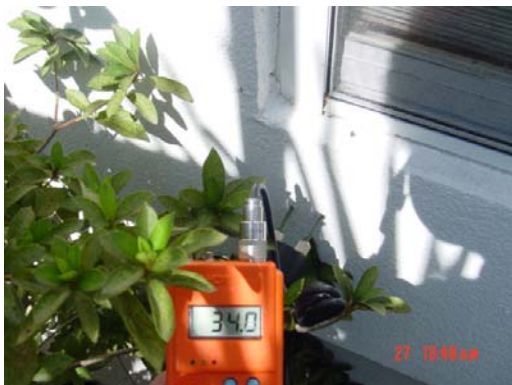
Detail Photo #5 -- No sealants at window lower left. High moisture reading at this window. Seal perimeters/construction.

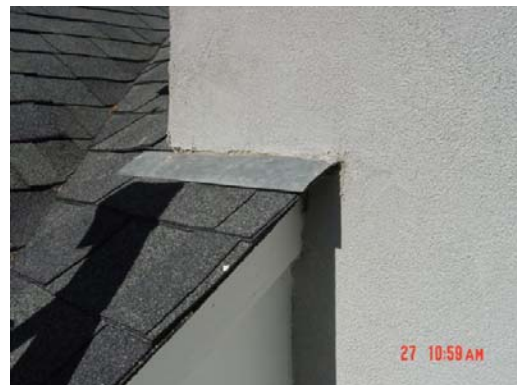
Detail Photo #6 -- EIFS is flush on roofing/flashing. Modify to prevent moisture intrusion.

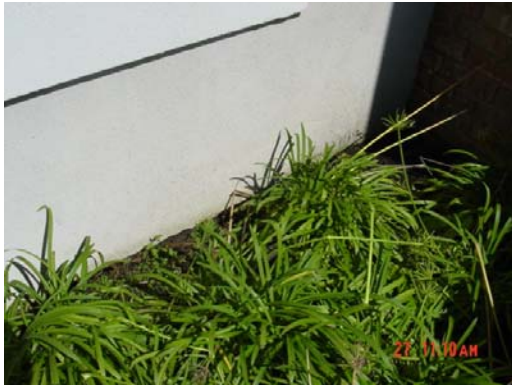
Detail Photo #7 -- Lower Edge. Landscaping is too close to foundation grade. Assess and modify.

- There is an area in your EIFS system that is close to the landscaping. This area should be modified to prevent moisture intrusion and insect infestation. Consult with a qualified waterproofing stucco contractor to check all bottom terminations and modify as needed by either cutting back EIFS or modifying the ground to allow proper clearance. Refer to elevation photos for specific locations.

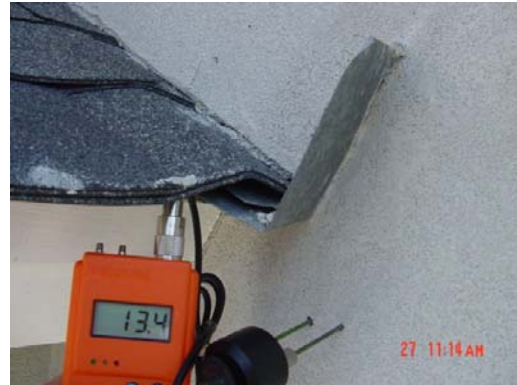
Detail Photo #8 -- Kickout flashing is present. Seal all kickouts.

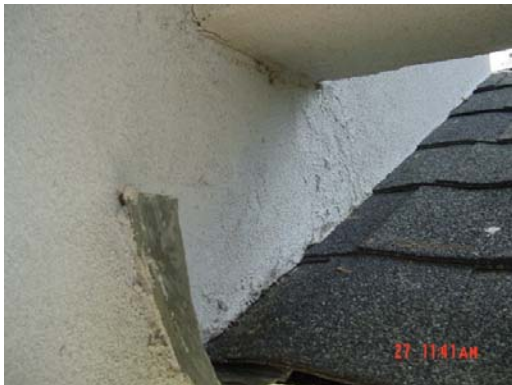
Detail Photo #9 -- Kickout flashing is present. This was installed after original EIFS installation. Noticeable patch. Seal.

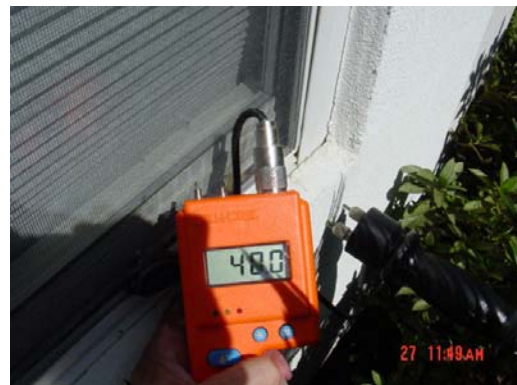
Detail Photo #12 -- No sealants at window lower right. High moisture reading. Seal perimeters/construction.

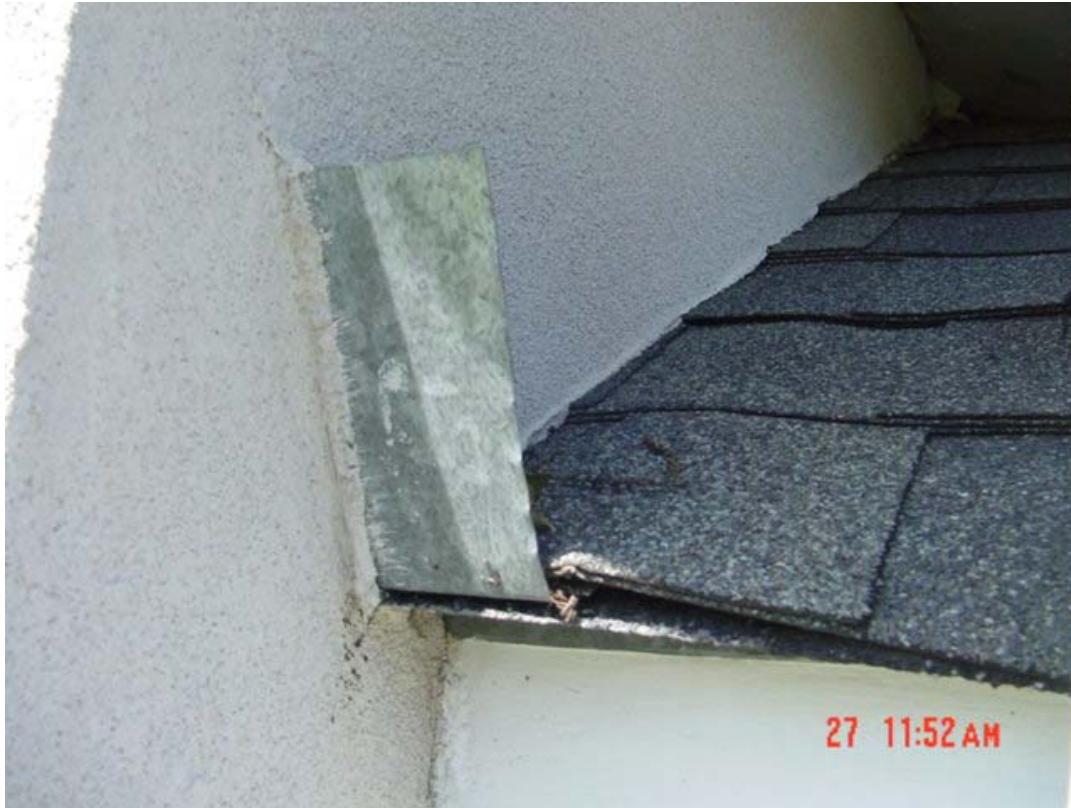
Detail Photo #13 -- Kickout flashing is present but there is a high moisture reading. Soft substrate noted. Consult a qualified waterproofing contractor to assess this location and modify as needed to prevent moisture intrusion. Seal all kickouts.
